Anı	RMA Company			
	<b>Concrete Inspection &amp; Comp</b>	pressive Strength Tes	st Report	
PROJECT:	Seaway Commercial Center	JOB #:	23-1344	
ADDRESS:	6801 Seaway Blvd, Everett, WA	REPORT #:	CB021	
PERMIT #:	B2203-043	DATE:	2/22/2024	
CLIENT:	SNBL U.S.A., LTD.	PAGE #:	1 of 4	
CONTRACTOR:	Foushee & Assoc Co Inc	INSPECTO	R: Tim Martin	
Sample Location:	10.25 Yards Placed. Line D to E/ 9.75 to	o 10.		Eq. No.
Supplier	Miles Sand and Gravel Company	Slump, in. (C143)	4.50	19
Mix #	02650C	Air Content, % (C231)	NT	
Mix Description	6.5 sk. Poly, 2% NC Accel, 100% HW	Unit Weight, pcf (C138)	NT	
Truck/Ticket #	1189 / 1093453	Air/Mix Temp.,°F (C1064)	41 / 71	A35
Strength Required	4000 psi at 28 days	Initial Cure Temperature, °F		A35
Quantity Placed, cy	420	Cure Method - Initial / Final	Container / Moist Roor	n
Time Batched	4:25 AM	Water Added on Job, gals	0	
Time Sampled	5:17 AM	Water Requested by	NA

# **Concrete Compressive Strength Test Report \* Continuation**

**PROJECT:** Seaway Commercial Center

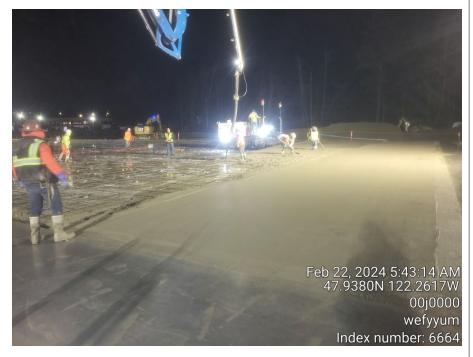
Image #1: The contractor placed the concrete starting at Line 10 using a boom pump.

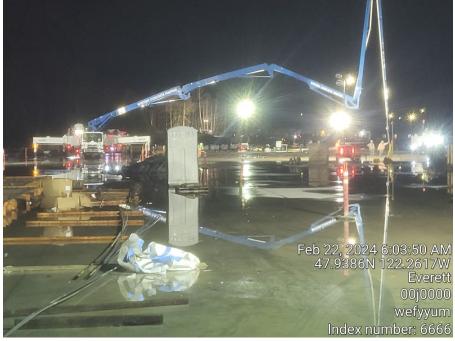
Image #2: Photo was taken looking southwest.

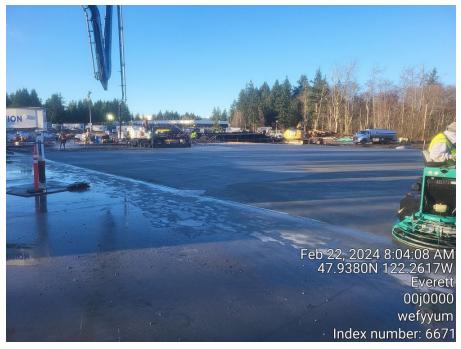
Image #3: The contractor is shown placing the concrete at the south end of the slab section as they are finishing the northern half of the slab.

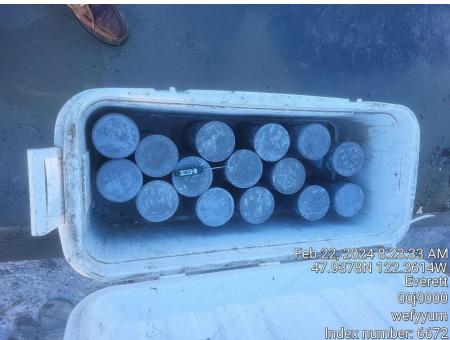
Image #4: Once cast the test cylinders were placed in this cooler for their initial cure.
